# QUALITY ASSURANCE MICROBIAL AND INDOOR AIR QUALITY SURVEY CLOSING REPORT EAST MIDDLE SCHOOL

09/26/12

PROJECT LOCATION: 377 MAIN STREET FAWN GROVE, PA 17321-9545

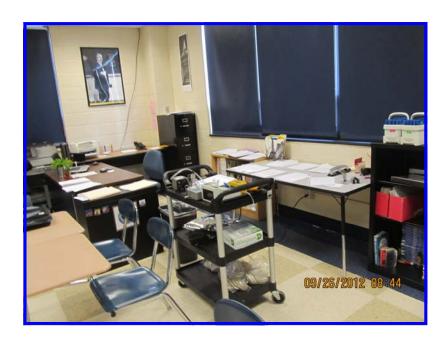
#### **SAMPLE LOCATION - ROOM # 126**

ASHRAE has also suggested that for optimum comfort, **Carbon Dioxide** levels should not exceed 700 ppm above ambient air. The C02 levels indoors generally, were well within the standard, however C02 readings were slightly elevated as compared to the standard in Room #'s 126 and 124. Elevated C02 levels could be the result of increased occupants and or activity in the space. Each of the room had a minimum of 22 occupants at the time the readings were obtained.

- 1) Correct roof leaks.
- Significant bacterial contamination was noted in many of the surface samples, including Room #'s 126, 124, 224, the Cafeteria, the Weight Room, the Wrestle Room, the Boys Team Room, the Boys Locker Room, The Library Office, the Girls Locker Room, The Girls Team Room and the Gymnasium. We are recommending that general housekeeping be upgraded in these areas of the school as well as all other remaining areas of the school. This housekeeping should include HEPA vacuuming throughout, including room contents, as well a cleaning all non porous surfaces with hot water, detergent and bleach solution with clean water rinse. This work can be completed by school Personnel.

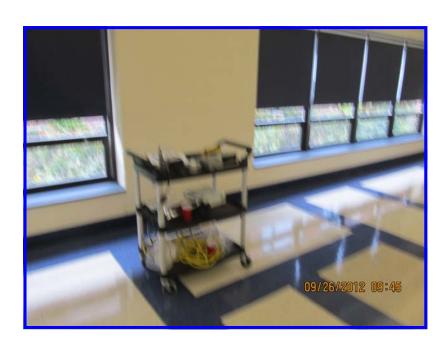
#### **SAMPLE LOCATION CAFETERIA**

The surface samples for fungi and yeasts obtained in each of the rooms tested revealed a moderate to high concentration of *Fusarium sporotrichioides* in the Cafeteria. The remaining surface samples revealed low levels of fungal contamination, NOT growth.

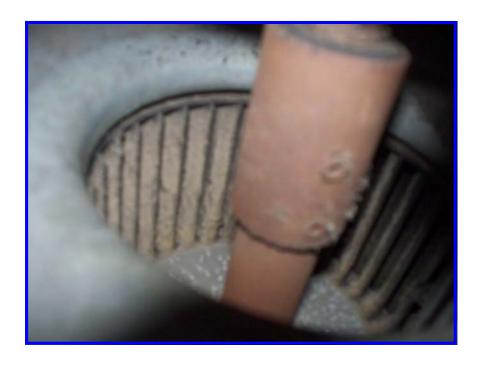
#### **GIRLS TRAINING ROOM-UNIT BLOWER**

The samples obtained in the Gym RTU, the Library Office, The Library Scanner Room, The Room 222 AHU, the Room 224 UV, the Office AHU and the Girls Training Room each revealed significant concentrations of fungal and/or bacterial contamination.

- 3) We are recommending that the Air Handlers in the Gym, the Library Office, the Library Scanner Room, Room 222, Room 224, the Office and the Girls Training Room each be cleaned via HEPA vacuum, the coils be cleaned with the patented, Aeris enzymatic coil cleaner and coated with Aeris Guard anti-foulant which will guarantee and inhibit mold growth for one year on the coils. Other hard surfaces in the units should be washed with detergent, rinsed and treated with the EPA registered sanitizer, Fast Attack. This work should be completed under the supervision of National Air Duct Cleaners Association (NADCA) certified Air Systems Cleaning Specialist (ASCS) and American Council for Accredited Certification (ACAC) Council Certified Mold Remediators. Routine cleaning of all HVAC units should continue, including the Aeris Coil Restoration. Filters should be changed twice yearly, unless conditions warrant more frequency. Filters should be replaced in the Cafeteria AHU.

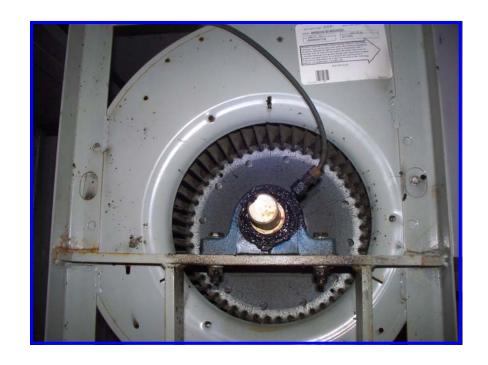
#### AHU # 3-OFFICE-BLOWER-SUSPECT MICROBIAL GROWTH

A total of seventeen air handler units were inspected as part of the survey. Generally, the filters and coils were slightly fouled with dust. Suspect contamination was noted on the blower fan in the Office unit. No visible evidence of contamination was noted in any of the other units inspected.

A total of seventeen air handler units were inspected as part of the survey. Generally, the filters, coils, drain pans, blower fans and insulation were noted to be in good condition however the drain pan in the Office AHU is rusted and suspect fungal contamination was noted on the blower fan in this unit. Additionally, the filters in the Cafeteria AHU were collapsing and should be replaced. No visible evidence of growth was noted in any other unit inspected.

We are recommending that these unit be professionally cleaned and treated with an EPA registered sanitizer.
